A Record of Repairs to the Leechwell, Totnes

As undertaken by the Leechwell Garden Association and Totnes Town Council

May 2015

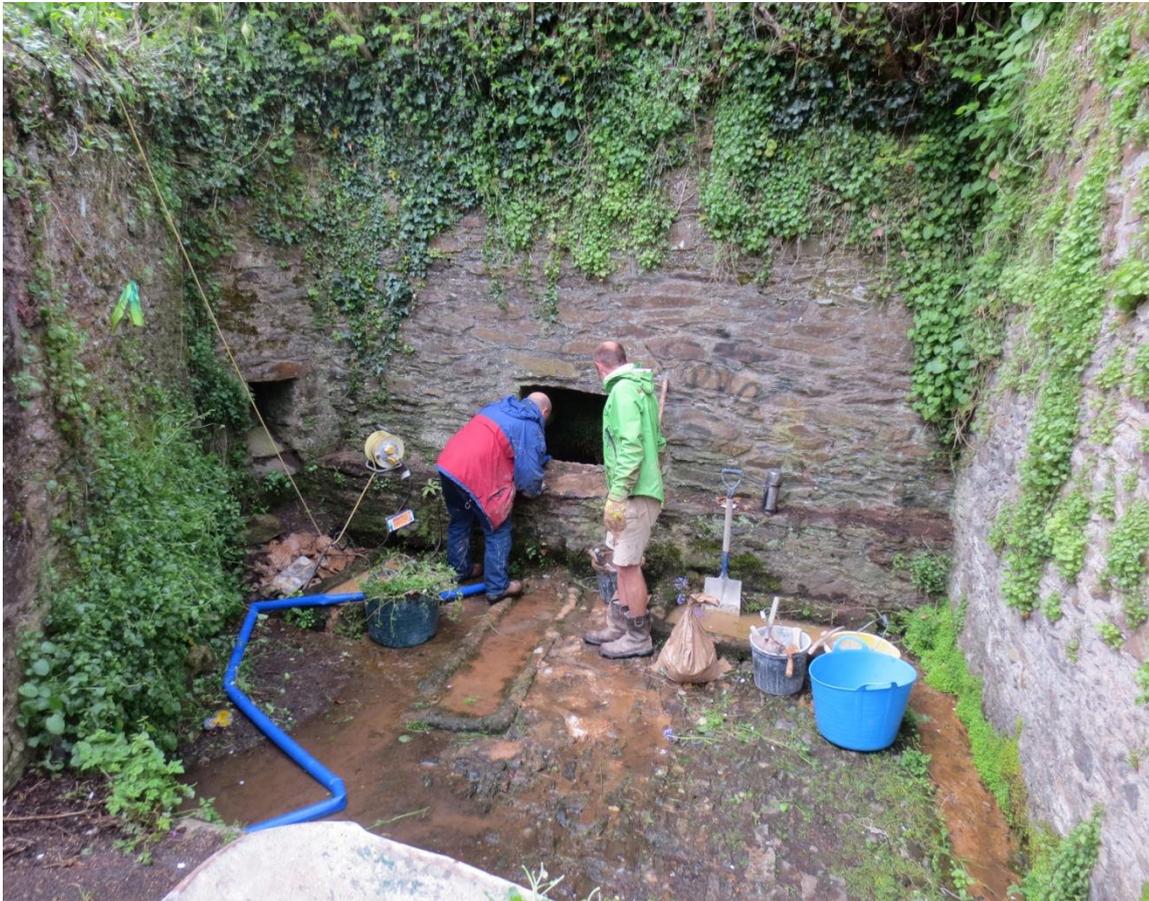
Fig.2 The well overgrown and neglected. Bruce and Will remove the old red clay base.

Bruce and Will removed the old clay puddling and found that it is very shallow, not what we expected, only about 5" deep. The big surprise is that beneath the clay layer is a concrete floor-covering the whole interior area (no idea how thick this is) So, the well is not puddled as everyone thought- it merely has a thin layer of clay laid over the concrete. There is a hole in the concrete, about 2ft square. This is not a constructed hole, but a jagged-edged one, clearly drilled or smashed out after the concrete had set. Two areas of little bubbles are welling up nearby.

The brief of this project is to remove the clay only, so for the time being the concrete is left where it is. Bruce and Will repair in the hole in the concrete and press new white clay on top of it.

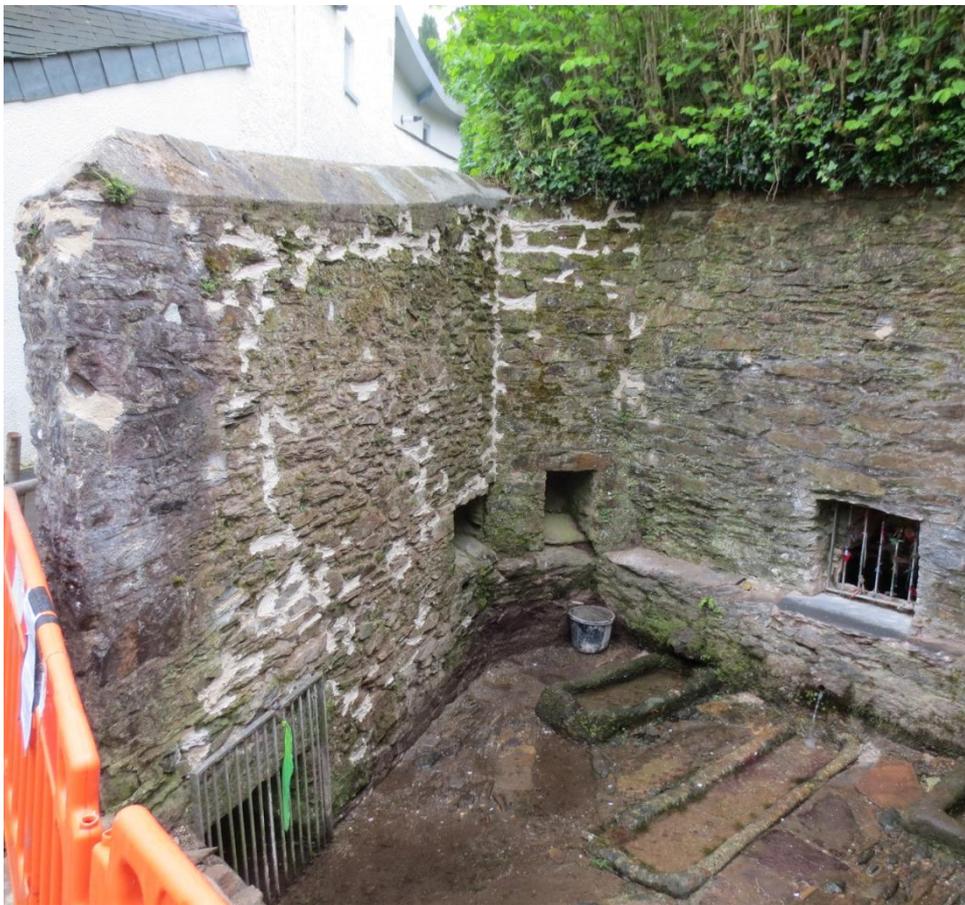
Fig.5 Caught just in time? Substantial repairs were needed to the left hand wall, probably the most recently built element of the well.

A lot of work was needed on this wall. A chunky piece of root (buddleia?) was embedded in the capping, which looked very unstable once the foliage was removed. Bruce plans one more day of work to complete on Monday.

Today was about repairs to the stonework using the Cornish lime, Chard sand and Sussex brickdust mix as specified by Oliver. This looked very bright when it went on the wall but will mellow to a sand colour quite quickly. It will be protected by hessian over the weekend. Bruce has removed the graffiti inside the well but there is still some on the nearby wall of the lane.

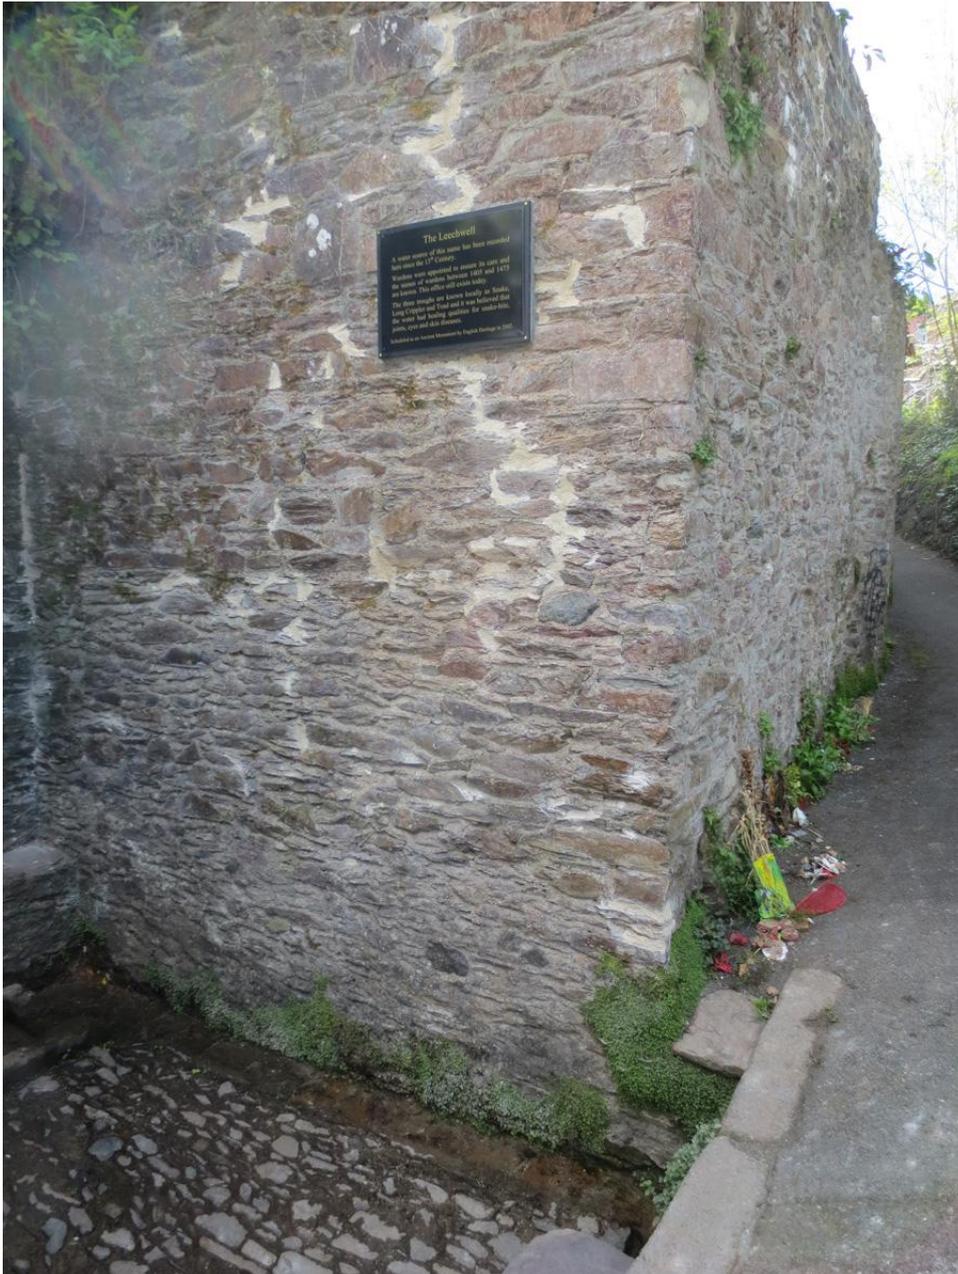
Fig.6 The board is unobtrusive but legible from below, the text can be found in Section 6. Hopefully, the board will be out of reach of graffiti artists. Some large cracks in the wall have been repaired. A depressed channel drains water along the base of the wall from the trough called 'Toad'.

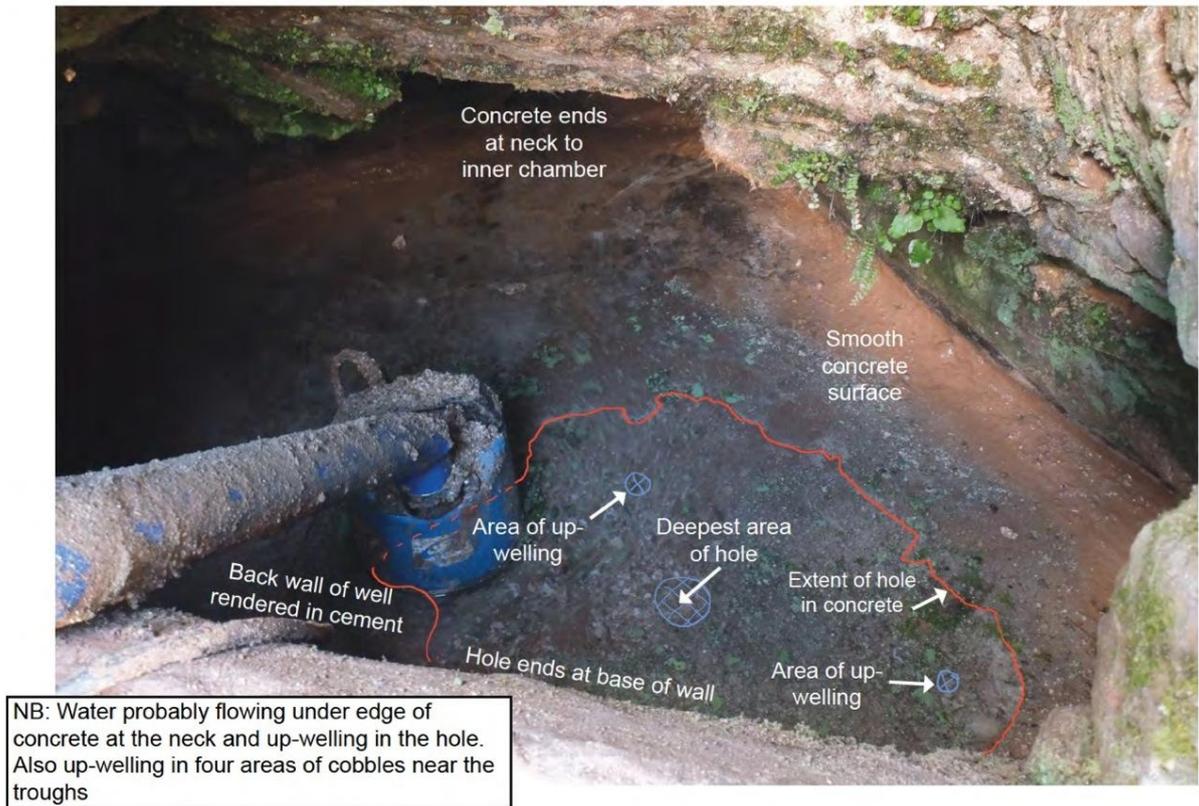
Fig.9 What was revealed when the clay, silt and debris were removed from the outer chamber

This revealed a smooth cement floor with an irregular hole in it, 18" to 2ft square. The hole is off centre towards the right and closer to the front wall. There is a deeper area in the centre of the hole, up to 18" deep. There are two areas of up-welling, these were noticed in 1996 when the well was last repaired. It was said at the time that the well was lined with tarmac.

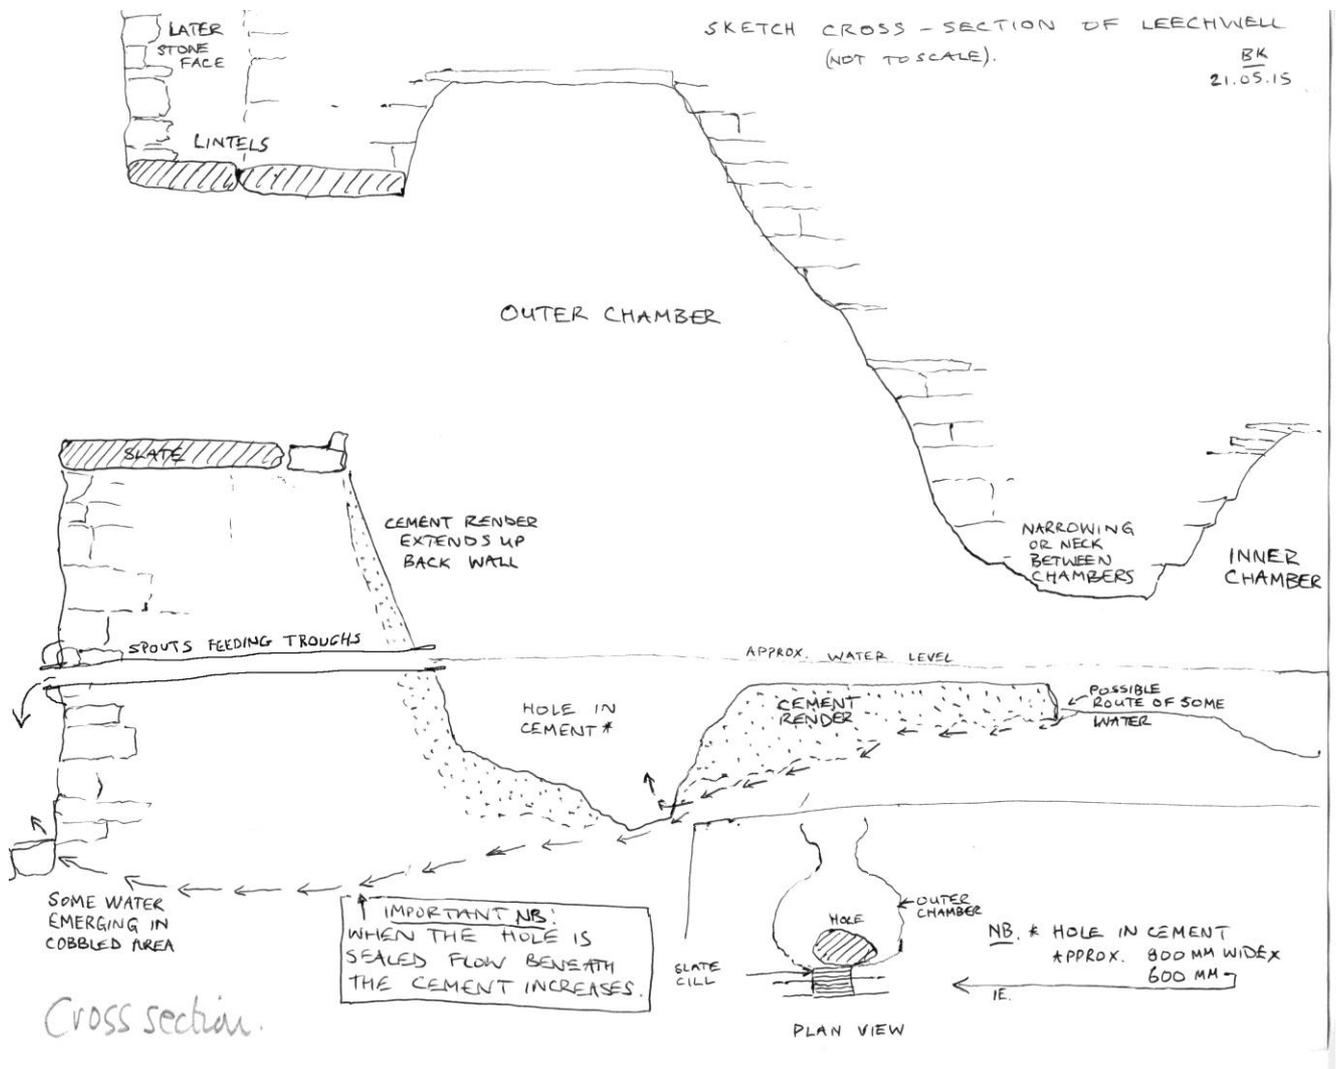
Fig.10 Cross-section and plan view of the interior of the inner chamber showing cement lining, hole, water level and position of spouts.

The cement may be at least 5" thick and extends up to sides of chamber and the back wall beneath the spouts. The centre of the hole may be 18"- 2ft deep and has areas of upwelling water. The water level in relation to the spouts is crucial- the clay helps to raise the water level above the concrete, but there is little leeway as the concrete is set just above the level of the floor of the inner chamber, the source of the water. When the hole is sealed the water ceases to flow.

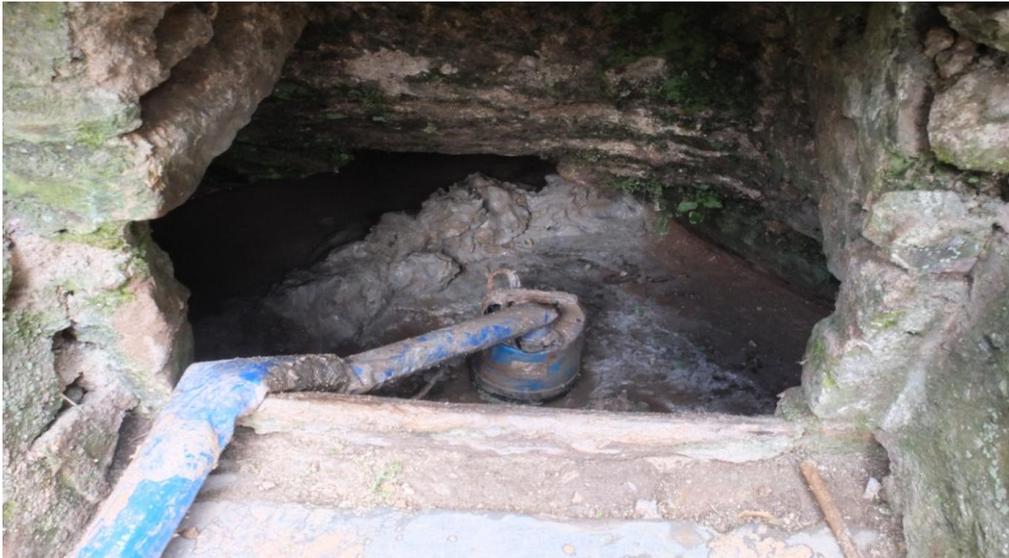
Fig.11 A dam was formed and a pump was used to remove as much water as possible.

Fig. 11 shows how the clay dam holds back the water so that repairs can take place. Two areas of upwelling were located. Hole sealed with stone, hydraulic lime NHL3 and Chard sand (ratio 1:2:5)

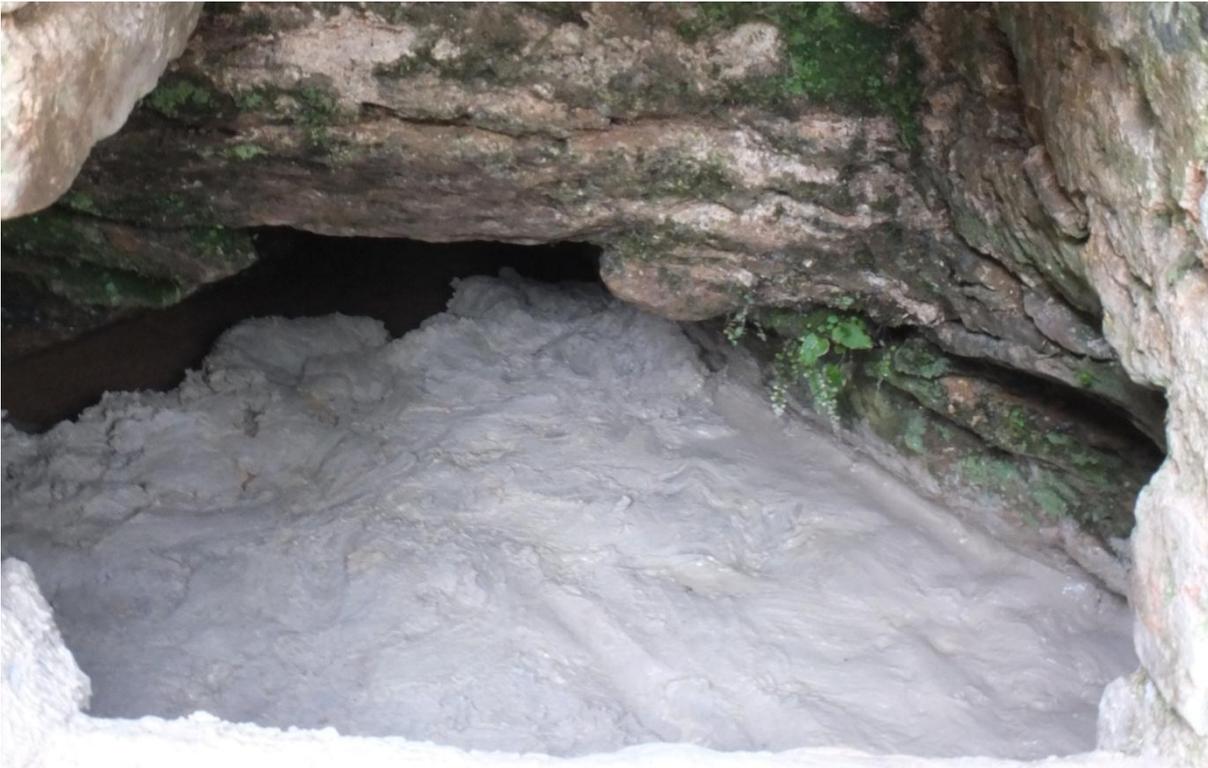
Fig.13 Working backwards towards the neck and channel with the clay. The shallow opening to the inner chamber can be clearly seen. The interior is in good condition, only a few small repairs were needed.

Once the hole was sealed, grey ball clay from Ringslade Quarry (soaked and worked to make pliable) was used to puddle the base and repairs, to seal leaks and to raise the water level behind the spouts.

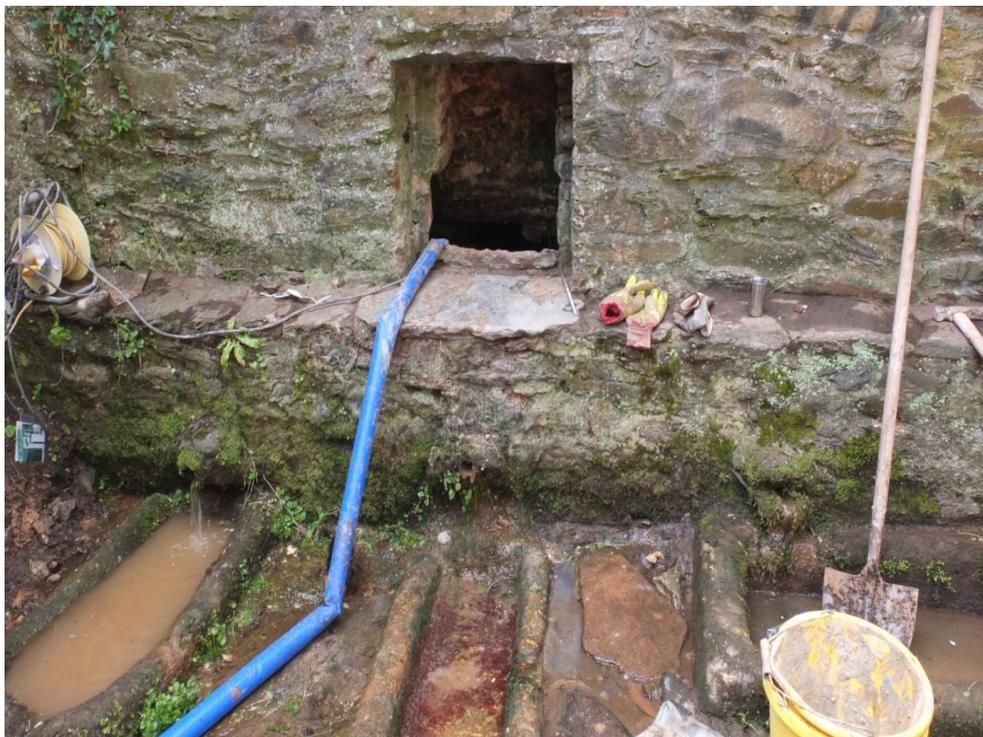
Fig.14 The channel beyond the dam is the last to be re-puddled.

The water flow through the left hand spout (which is fractionally higher than the other two) initially increased due to pressure of the dam but was lost as the dam was removed. However, the following day the water flow through all three spouts had almost gone and the flow through the cobbles increased. As a result, Oliver and Bruce decided to reinstate the hole in the concrete and make channels in the clay to bring water to each spout, at which point the flow through the spouts quickly increased.

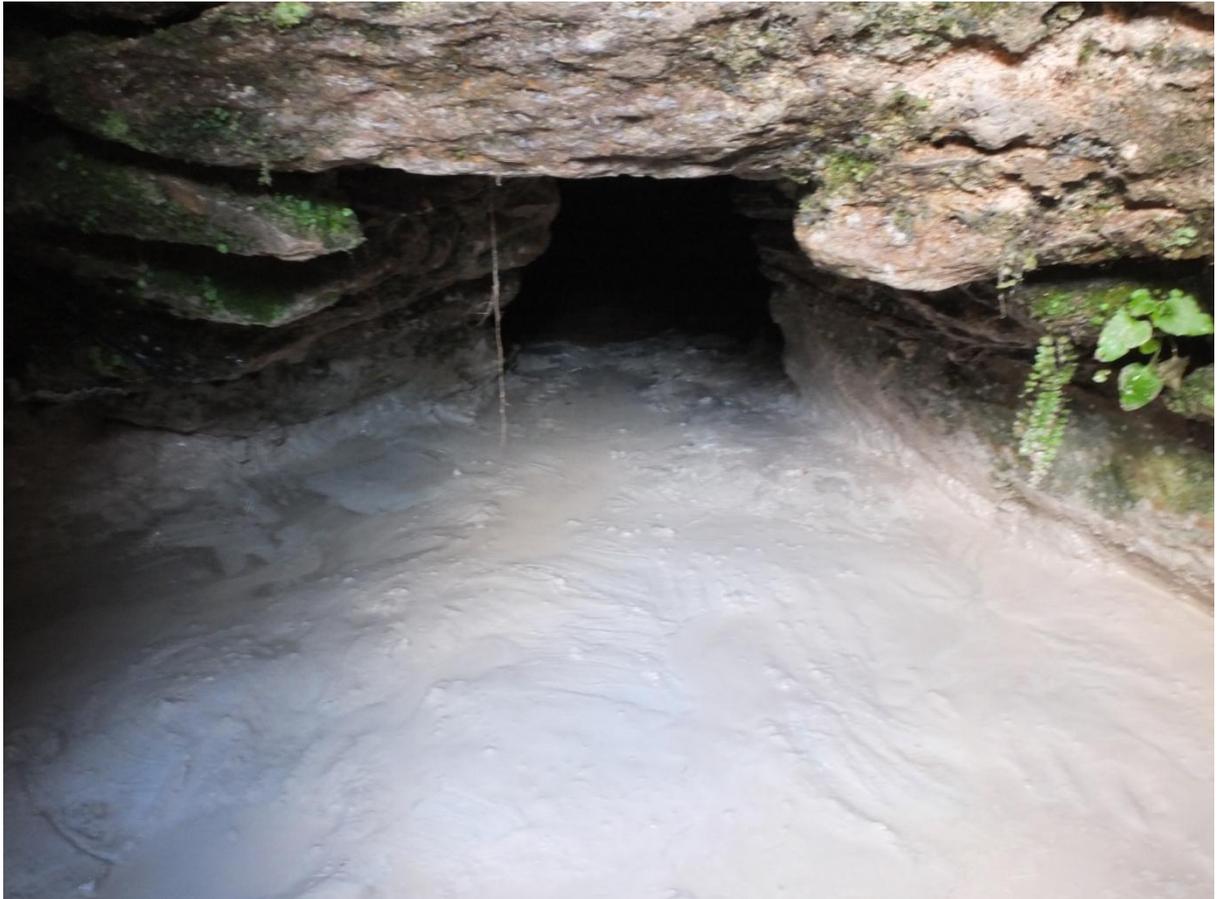
Fig.15 Newly re-puddled interior complete.

This shows the clay smoothed out and water flowing in from the back entry to the inner chamber. The stonework dividing the two chambers is generally in good condition. Bruce wonders if the inner chamber is possibly not as natural as originally thought... one more mystery to ponder over?
