A Record of Repairs to the Leechwell, Totnes

As undertaken by the Leechwell Garden Association and Totnes Town Council

May 2015

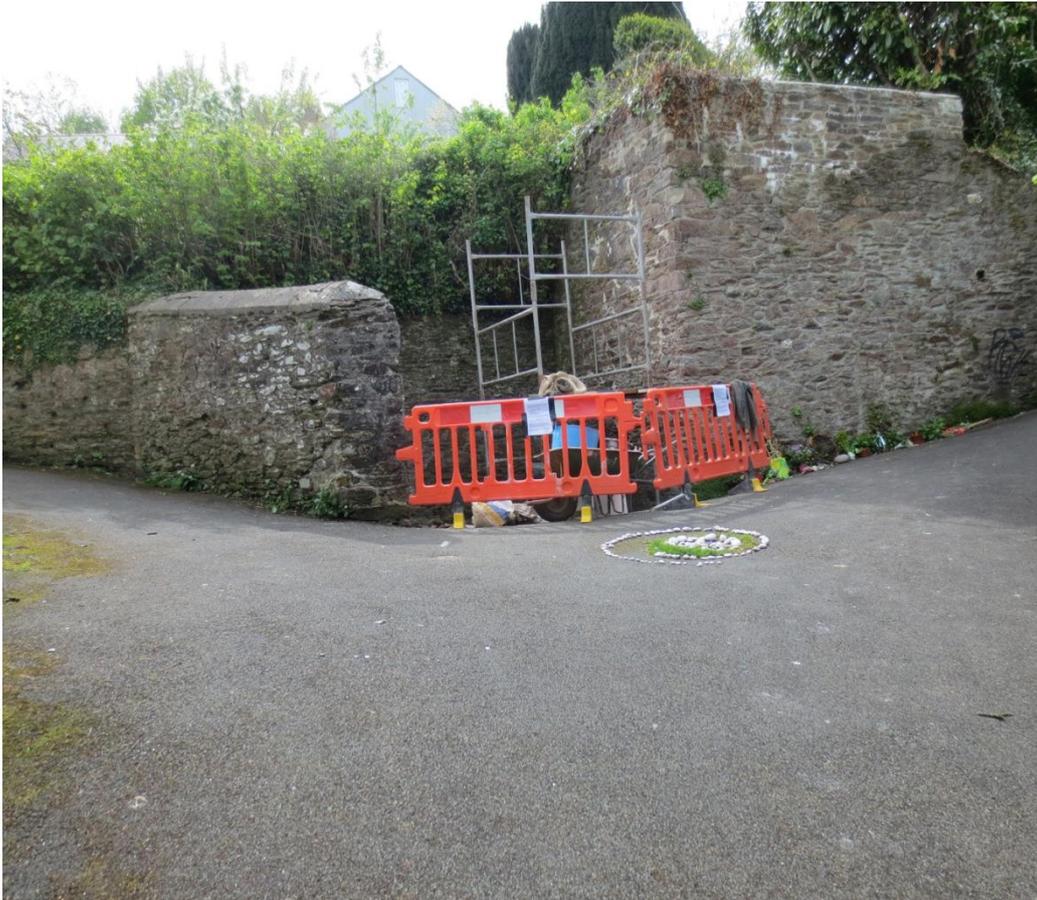
A much-visited and much-loved site in Totnes the well has nevertheless suffered years of neglect. The well was last repaired in 1996 when it was said that a layer of tarmac had been removed from the outer chamber and the base re-puddled with clay. By 2013, water was seeping away through the floor of the outer chamber so that the water supply to the granite troughs was almost non-existent, the cobbled basin was clogged with sludge, grass and stagnant water, ivy, buddleia and other foliage was growing in the outer walls and the stonework and wall capping was badly cracked. The information board had been lost many years ago.

Fig.1 View from Leechwell Lane. The Lane divides here, leading to Maudlin Road on the left and to the Kingsbridge Inn on the right. The garden of Westhill House lies above the back wall of the well. The pebble spiral was created during earlier May celebrations here.

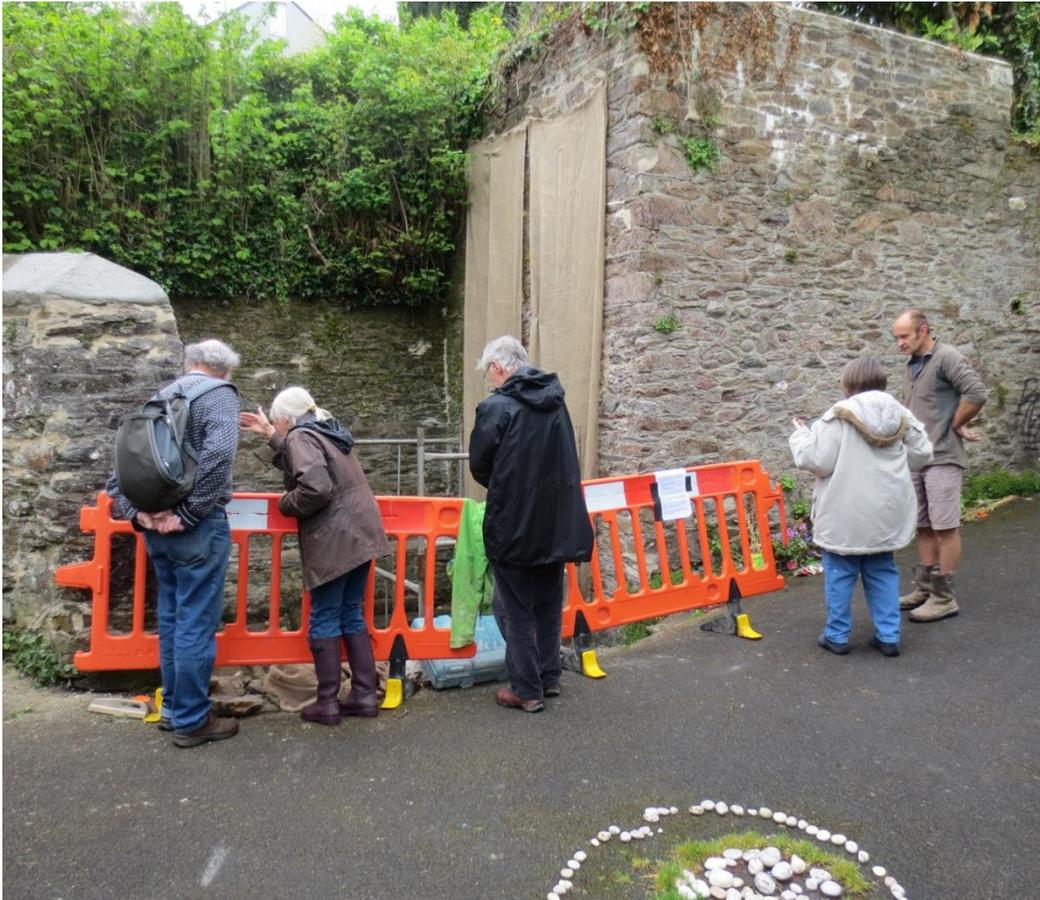
Fig.3 Meeting at the well. Left to right: James Bellchambers, Shirley Prendergast, David Martin, Pruw Boswell, Bruce Kirby. Dave Mitchell is taking the photograph. (The hessian protecting the new lime mortar is still in place)

After discussion it is decided that Bruce will complete the job as agreed- ie fill cracked stonework and capping, clear silt and debris, clean the cobbles and put up the new notice board. If the water continues to flow through the spouts (two fairly strongly) that is a great improvement. The whole area will function better, look better and be more secure. *Short of removing the concrete little more can be done for now.*

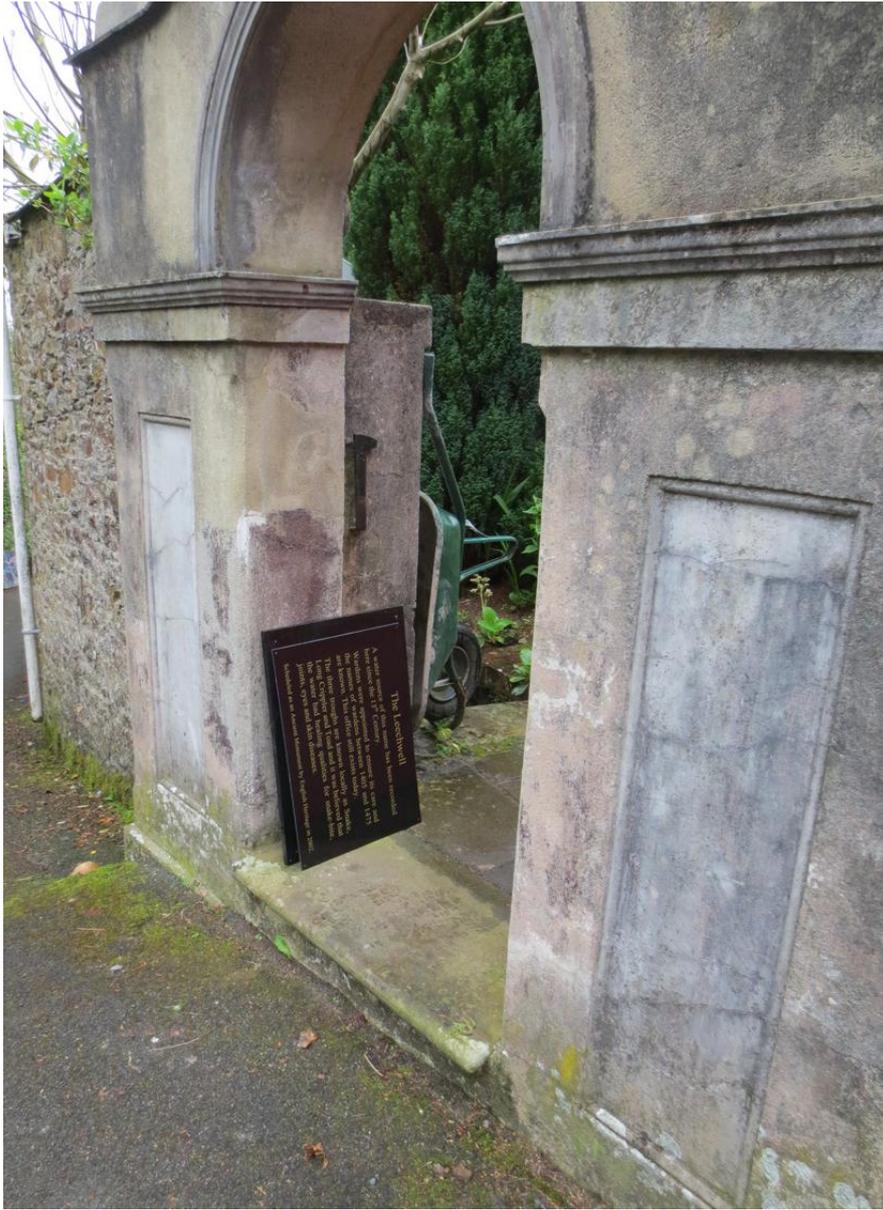
Fig.4 The new information board mounted on marine ply. Thanks to the Mitchells, Bruce was able to link up a power line and store some of his equipment in the garden of Leechwell Cottage, opposite the well.

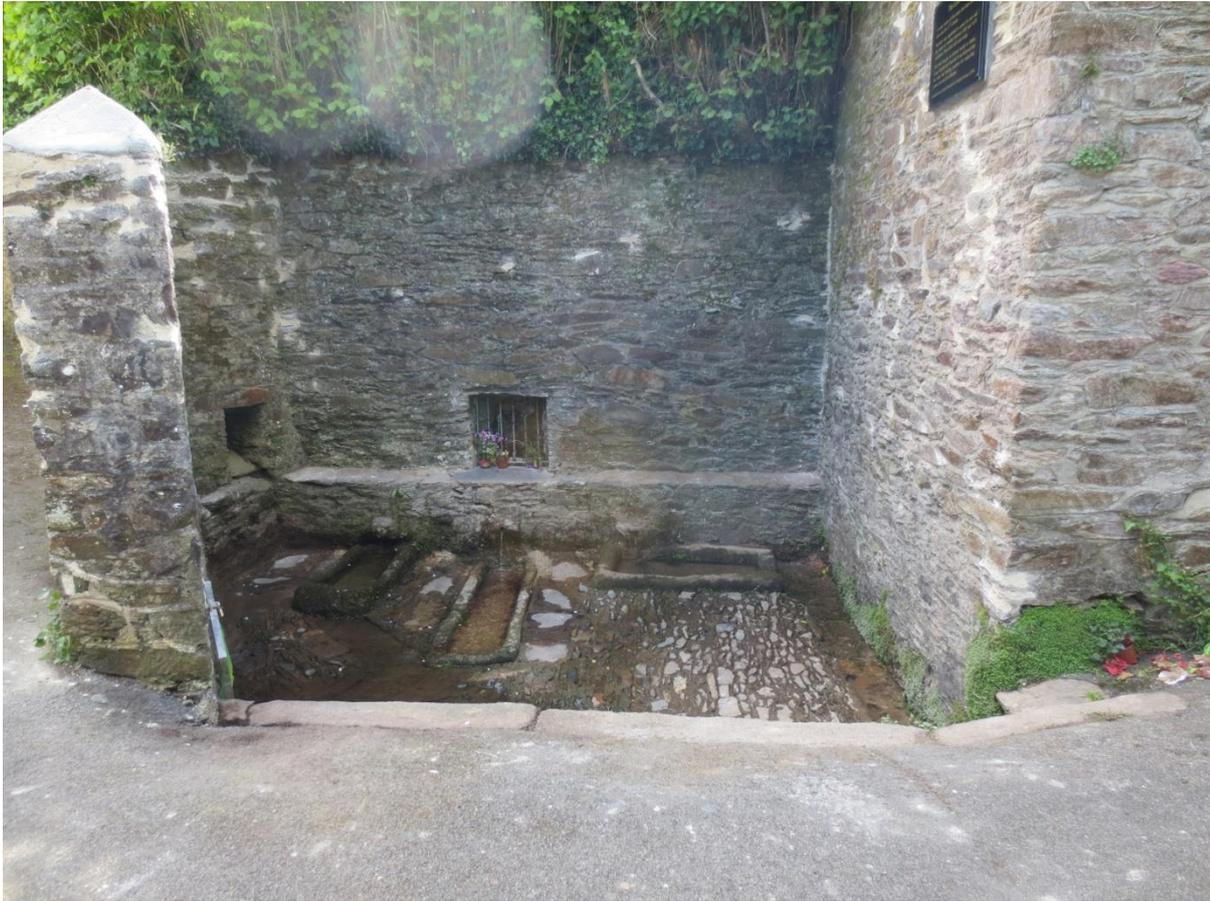
Fig.7 This is a glimpse of the well as the living place it must once have been: a cared-for and highly valued resource with a powerful atmosphere of spirit of place, reflecting the well's uniqueness and antiquity as one of the most significant in Devon (according to Faull, 2005).

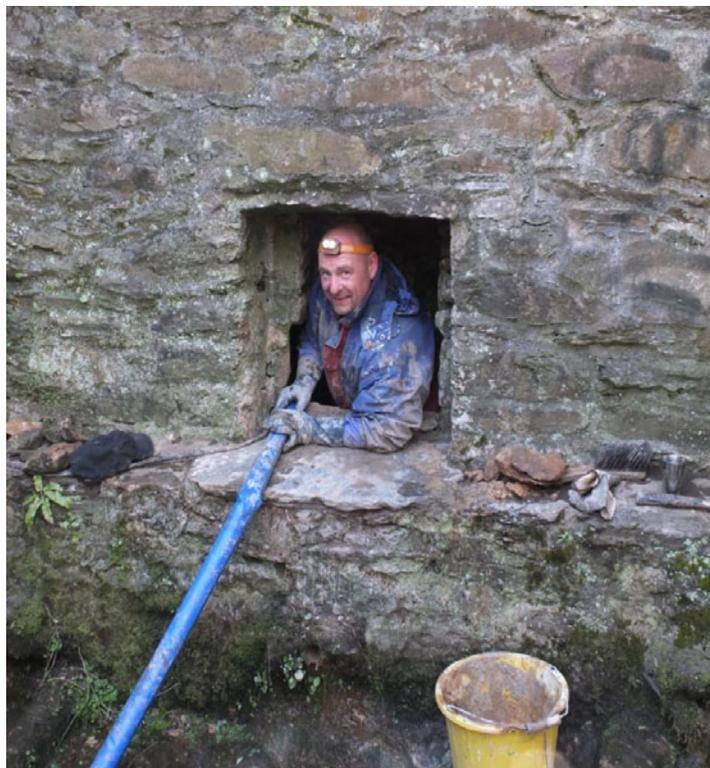
Fig.8 Day1: Will manages to squeeze inside the outer chamber.

This revealed a smooth cement floor with an irregular hole in it, 18" to 2ft square. The hole is off centre towards the right and closer to the front wall. There is a deeper area in the centre of the hole, up to 18" deep. There are two areas of up-welling, these were noticed in 1996 when the well was last repaired. It was said at the time that the well was lined with tarmac.

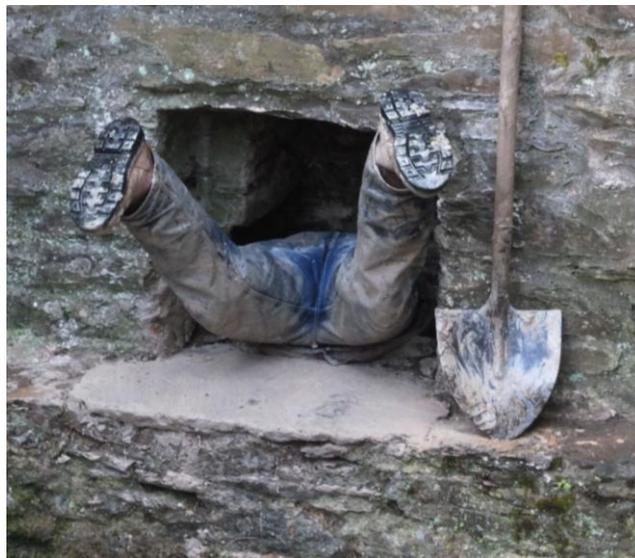
Fig.12 The Webb technique!

Once the hole was sealed, grey ball clay from Ringslade Quarry (soaked and worked to make pliable) was used to puddle the base and repairs, to seal leaks and to raise the water level behind the spouts.
